HITACHI BULLETIN

M1LXU & A3LXU POWER SUPPLY

TECHNICAL BULLETIN - BULLETIN TECHNIQUE

No. TB0240

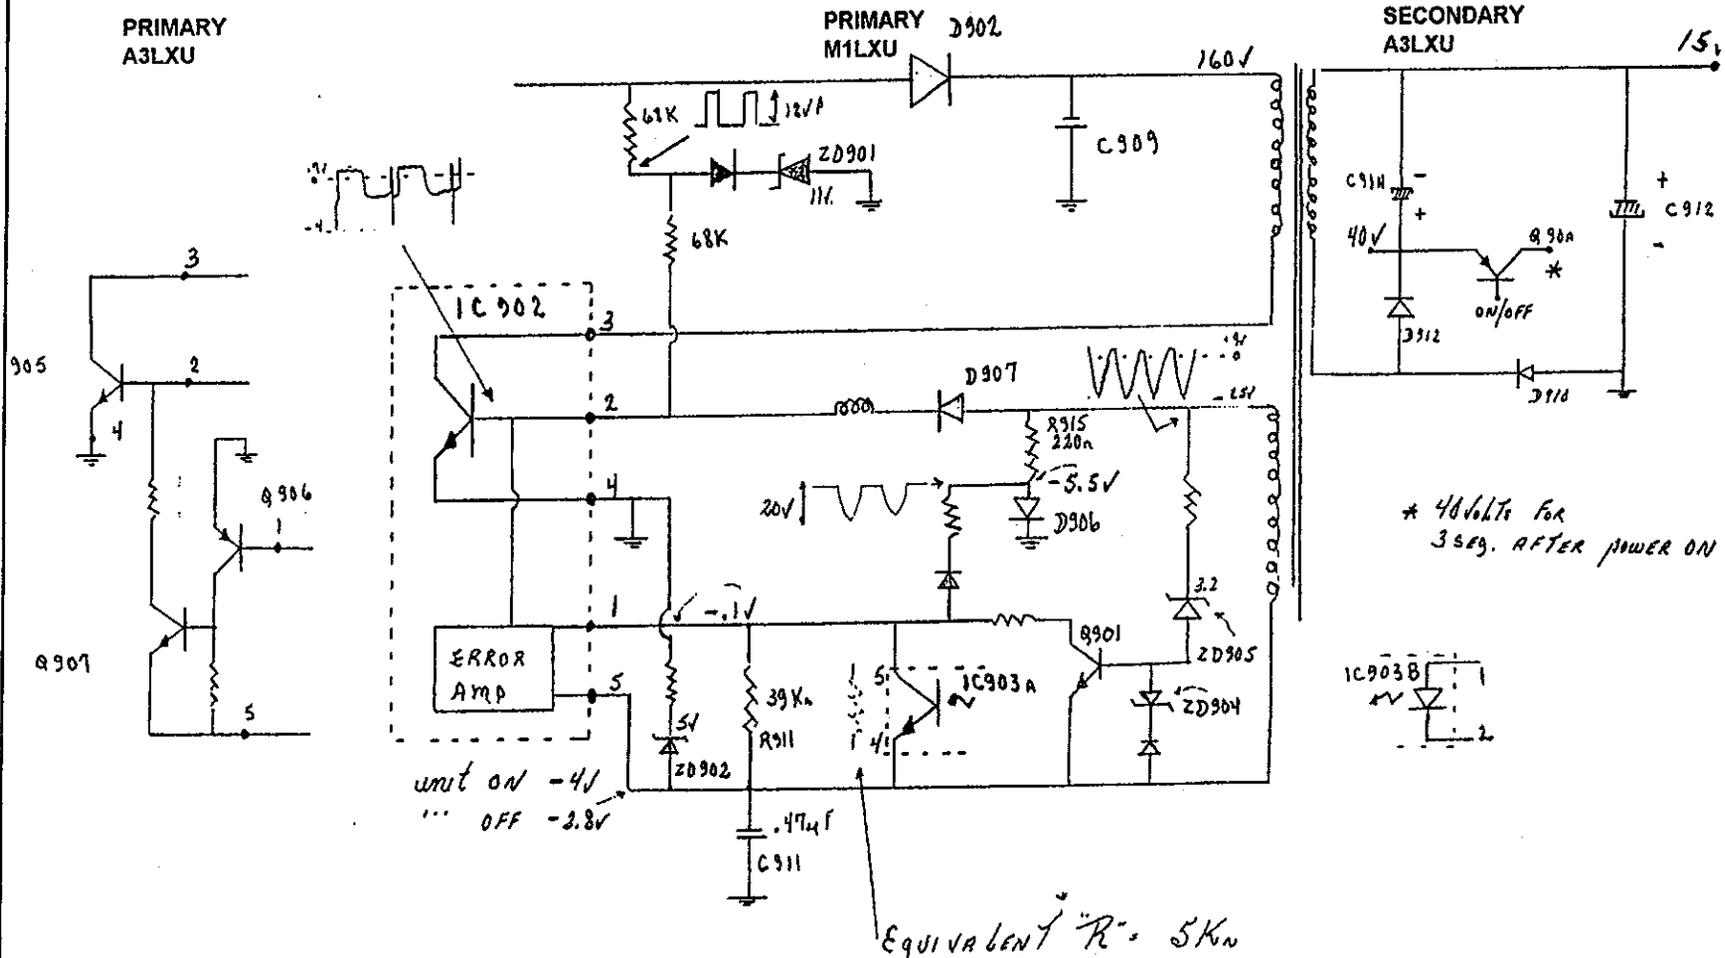
M1LXU and A3LXU

NOTE: Component values and identifications vary from M1LXU to A3LXU chassis. The attached drawing is a block diagram applicable to both chassis.

A3LXU uses 3 transistors instead of IC902.

The secondary drawing used on the following page is for A3LXU.

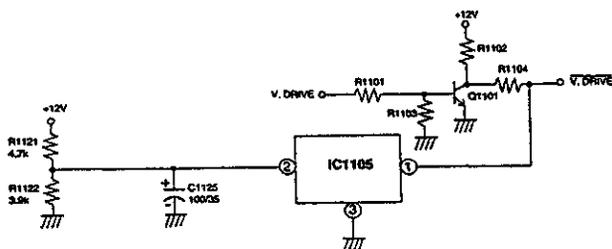
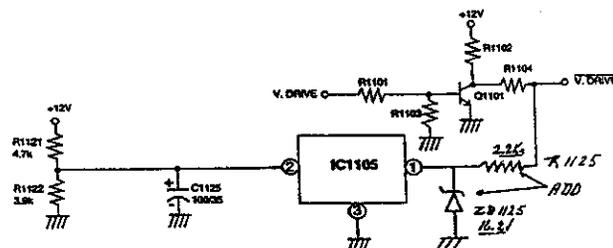
SUBJECT/SUJET: CONVERGENCE PROBLEM CAUSED BY IC1105.

IC1105 is located in IC1101 location on PCB. Also, IC1105 Pin numbering is reversed of PCB diagram.

When IC1105 is replaced, the following modification should be performed:

R1125 (2.2KΩ 1/16W) should be installed in series with Pin #1 of IC1105 (Part # 0700045)

ZD1125 (16.2Volts) should be installed parallel with Pin 1 and 3 of IC1105 (Part # 2334243)

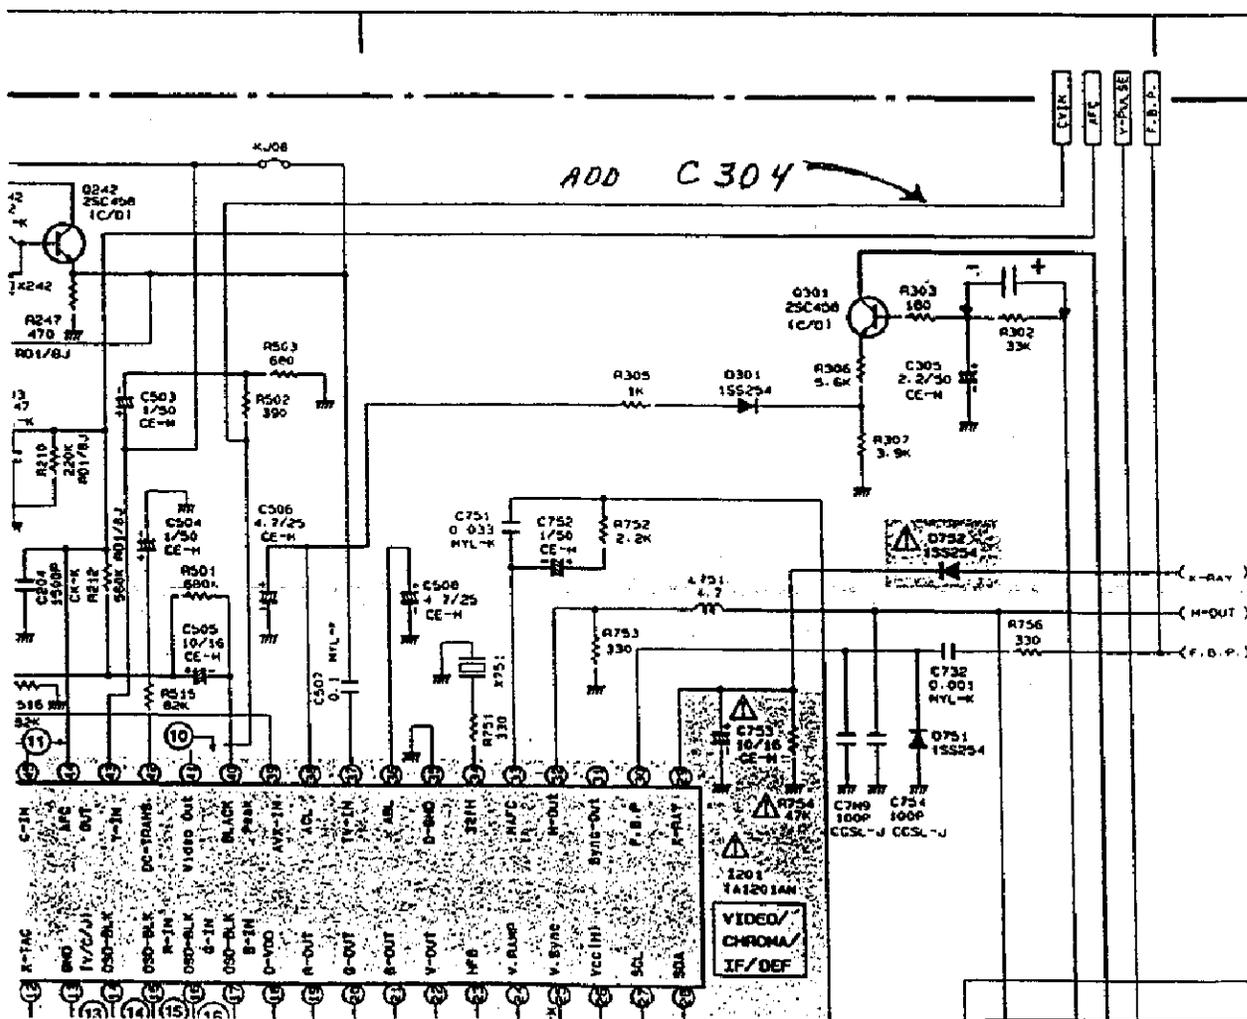
SUBJECT/SUJET: SHUTDOWN PROBLEM - MODEL 27CX5 - 27CX25 CHASSIS M3LXU

The physical location on the PCB of R302 is between vertical section and video audio auxiliary jack. See diagram below.

If you have experienced a shutdown problem with either of the above mentioned models, please add capacitor C304 - 0.47µF/50V. (Part # 0800001) parallel to R302, and secure with silicone glue.

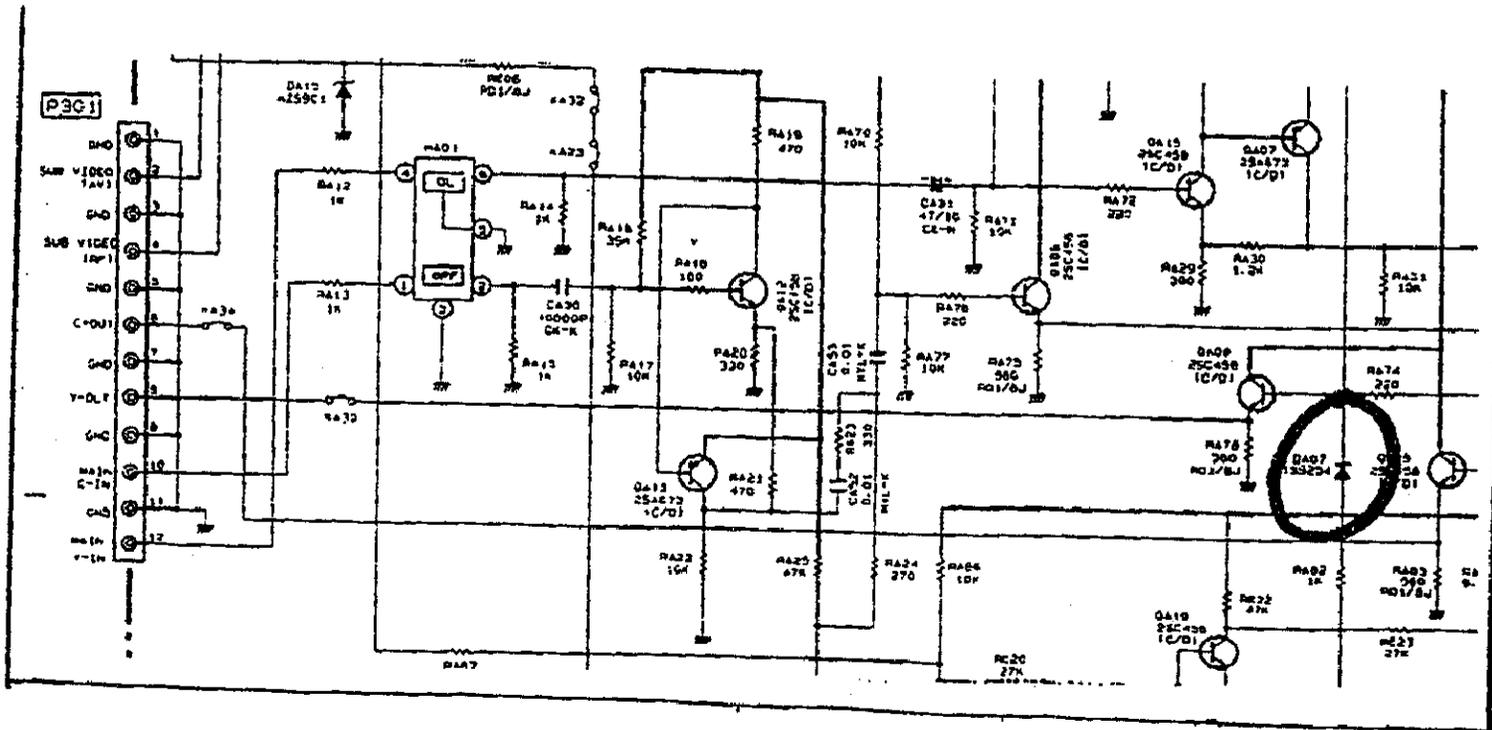
SUBJECT/SUJET: BLANK OR DELAYED PICTURE WHEN ON PinP SELECTION.

Picture stays blank or is delayed when the signal of PinP (auxiliary input) is changed and unit is in SWAP mode.

Delete diode DA07 from PinP PWB. Schematic diagram below: -
