INSPECTION

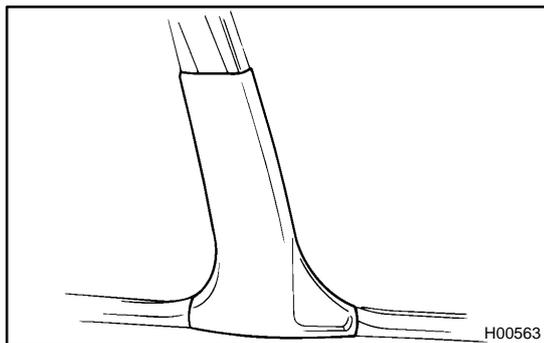
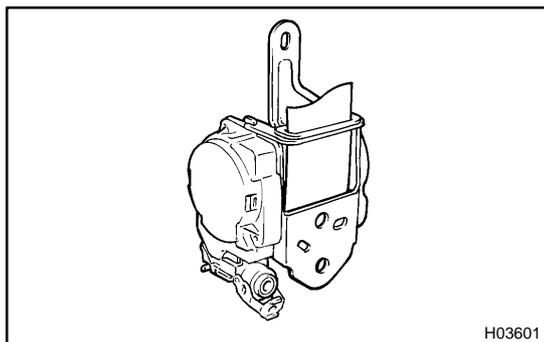
- (a) Perform a diagnostic system check.
(See page [DI-459](#))
- (b) Perform a visual check which includes the following items with the front seat outer belt removed from the vehicle.
 - Check for cuts and cracks in, or marked discoloration of the center pillar lower garnish.
 - Check for cuts and cracks in wire harnesses, and for chipping in connectors.
 - Check for deformation of the center pillar.

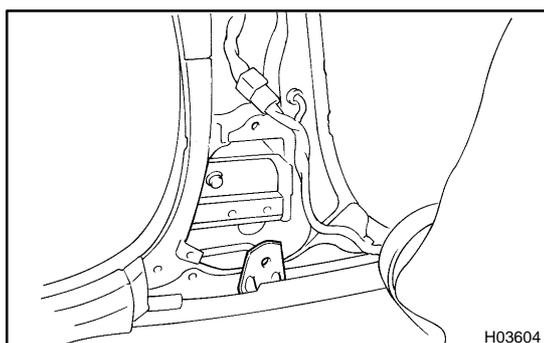
- (a) Perform a diagnostic system check.
(See page [DI-459](#))
- (b) Perform a visual check which includes the following items with the front seat outer belt removed from the vehicle.
 - Check for deformation of the center pillar.
 - Check for damage on the connector and wire harness.
