INSPECTION

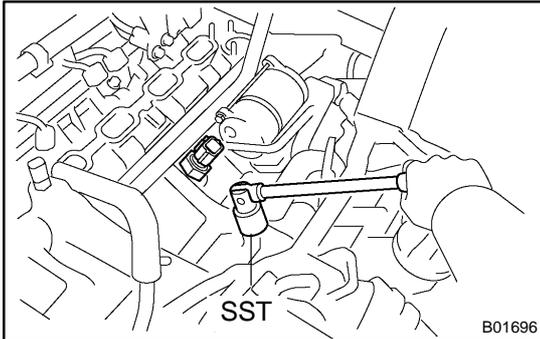
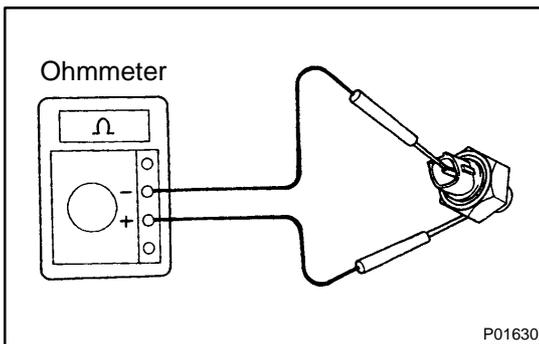
1. REMOVE V-BANK COVER
2. REMOVE BATTERY CLAMP COVER, AIR CLEANER INLET AND INTAKE AIR CONNECTOR
3. DISCONNECT THROTTLE BODY (See page SF-59)
4. REMOVE INTAKE MANIFOLD ASSEMBLY (See page EM-34)
5. REMOVE KNOCK SENSOR
 - (a) Disconnect the knock sensor connectors.
 - (b) Using SST, remove the 2 knock sensors.
SST 09816-30010
