# Disassembly Caution for LED-H TV Servicing Prep.

# Fast Track Troubleshooting Manual

# '2012 LED Hybrid Disassembly **cautions** for Front Cover

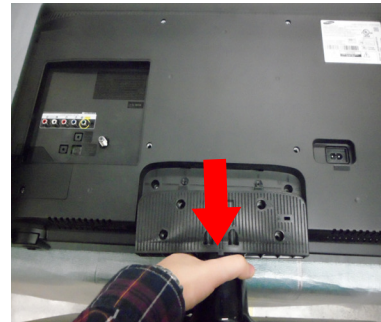
3. Remove stand.

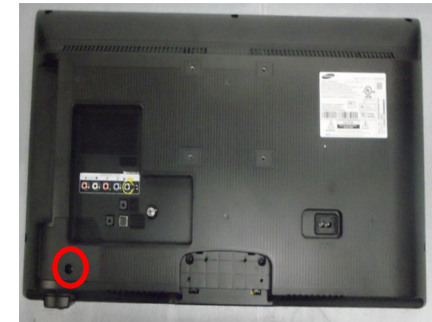
4. Remove the 1 screw of cover jack.

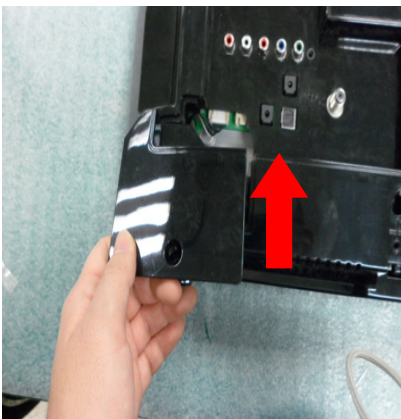
5. Remove cover jack.

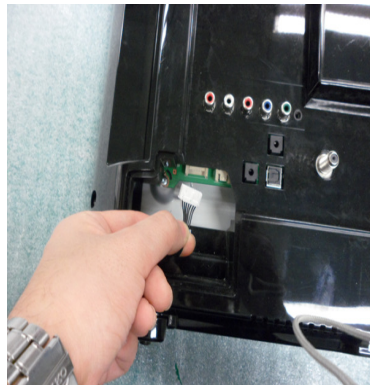
6. Disconnect the function Assy. Cable

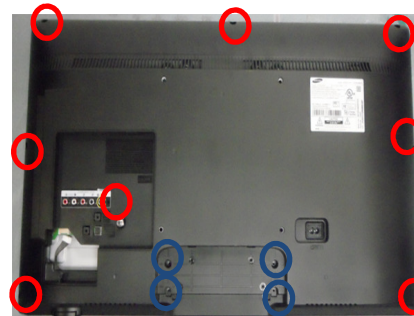
7. Remove the screws of rear-cover.

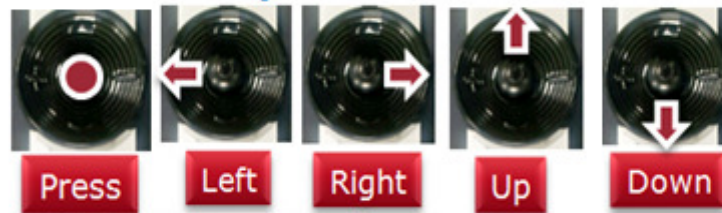
UNEH4000 Sample

## 5 Directional Function Control

# Function Control Troubleshooting

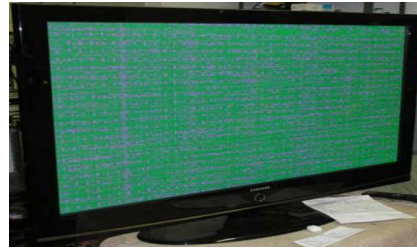
Green lines or a green screen  
defective main board , LVDS , or  
T-CON.

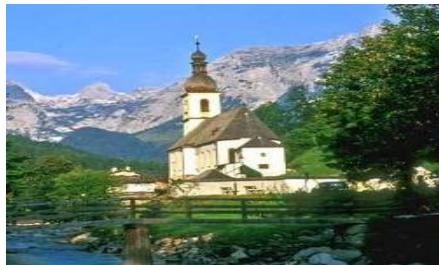
Original Image

Pixelization can be caused by the main board  
but is more commonly a source error

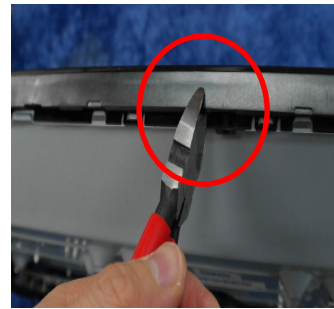
2. **Cut and split** the cover off at the top

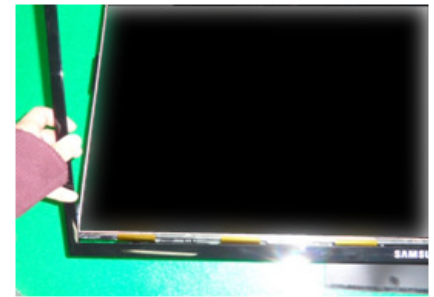
3. Carefully remove the Front Cover and insulated paper in Front of T-Con area.
