FRONT LOWER BALL JOINT ON-VEHICLE INSPECTION

SAQJ-01

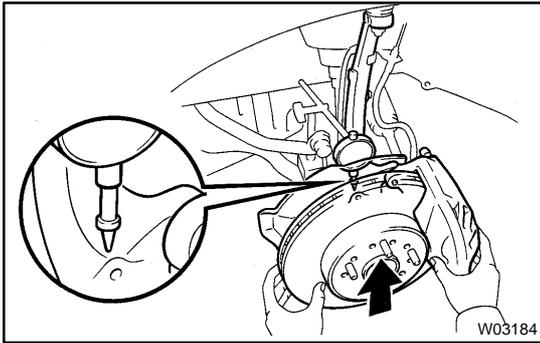
- (a) Remove the tire and check the lower ball joint boot. If the boot is damaged, replace the lower ball joint.
- (b) Place the magnetic base on the strut bar and position the spindle of the dial indicator to the knuckle arm as shown below.
- (c) Check the excessive play of the lower ball joint when you push the axle up with hands.

Maximum play: 0.3 mm (0.0118 in.)

If it is not within the specification, replace the lower ball joint.
